Real Estate Inspection Report

Prepared Exclusively for: Eddie Haskell
Inspection Performed on
01/15/20

3430 Canyon Oaks Ct Monterey, CA

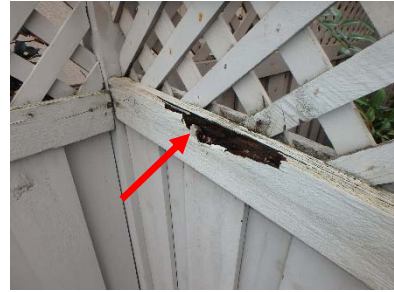
Example – Deteriorated Fencing

[MRR] The right-side gate latch arm is loose and the gate drags the ground. Fencing at several areas around the rear yard is loose and deteriorated. Budget for repairs and future maintenance. Fence Contractor.

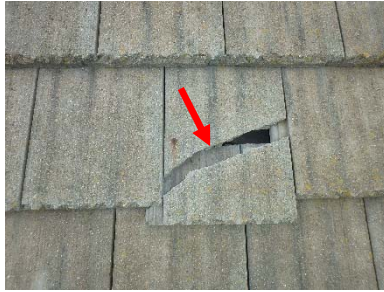
Damaged Tile

[MRR] Inspection of the roof covering revealed the following conditions: There are two tiles which were adhered together at the top left section of the roof. One tile should have been trimmed to fit around the top of the ridge and a cut tile should have been installed at one end of this row/course. This was probably a result of poor planning by the roof installer. The sealant used to join these tiles together is cracked. Sealant should not be used here, as it is prone to crack when exposed to sunlight. A piece of malleable flashing should correct this. Excessive moss growth was observed at several areas. Debris and moss growth observed in roof valleys, atop the roof covering and in the gutters. A section at the rear of the roof, where the wall extends out, is difficult to make weathertight. Care and attention to detail is required here to prevent water from getting beneath the roofing paper. Presumably, this is the reason the roof sheathing was replaced in this area. While a new piece of roofing paper was installed above the repair area, there is still deteriorated roofing paper above this area, where water can get to the roof sheathing. These conditions can result in a roof leak. Roofing Contractor.

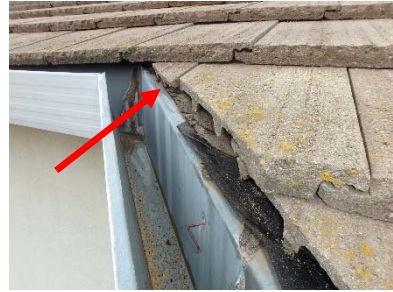
Deteriorated Roofing Paper

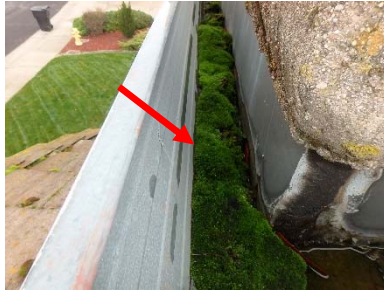
Example – Debris in Gutter

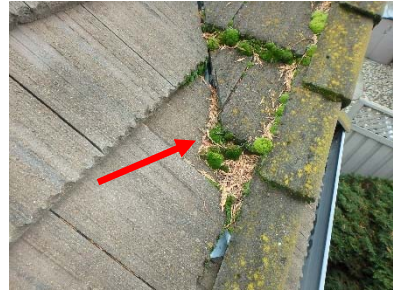
Example – Debris in Valley

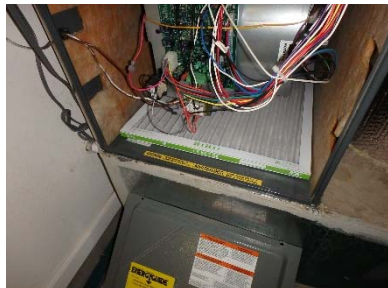
Air Filter Inside Furnace Cabinet

[MRR] The air filter is located at the base of the furnace cabinet. The furnace is not designed to house the air filter here, as it is loose-fitting and will not filter all the air. Presumably, the air filter was once installed at the return air grill in the hallway. You can see that a different return air grill was installed, one without an openable cover. Presumably, the person who had this done, wanted to access the air filter from a location that didn't require the use of a ladder. If you'd like to keep the air filter located inside the furnace cabinet, have an HVAC contractor devise a means to keep it securely in place, so all the air gets filtered and prevents the evaporator coil and fan motor from getting dirty. Or, you can have an HVAC contractor install a return air grill in the hallway ceiling, which will accommodate an air filter.

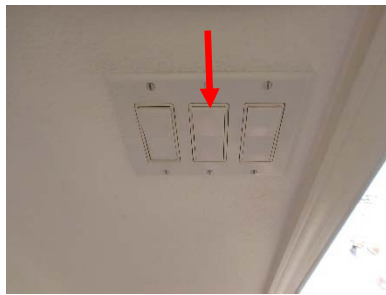
At Rear Door

[NOTE] Unknown switch purpose detected at the rear door. Middle switch. Unused circuit at the exterior? Refer to seller.

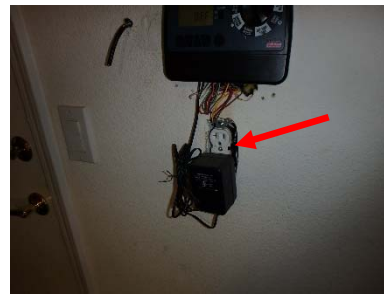
Right Side Garage Wall

[HSC] The outlet at the right-side garage wall, beneath the irrigation timer is not GFCI protected. Presumably, a single pole outlet was once installed here and those are not required to be GFCI protected, if only the irrigation timer can be plugged in here. Install a single pole outlet and cover plate OR a GFCI outlet and cover plate. Electrical Contractor.

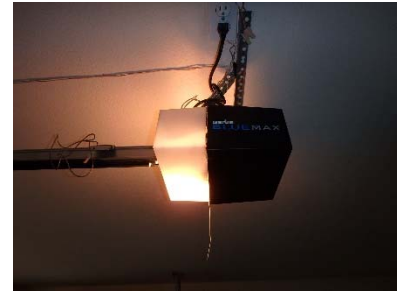
Garage Door Opener

[HSC] The electric garage door opener safety reversal system should reverse the door after 15 lbs. of resistance is encountered. The garage door did not reverse with more than 15lbs of pressure exerted on the door as it was closing. This is an unsafe condition. Overhead Door Contractor.
