Hazards of the Consolidated Industries H-Series Horizontal Atmospheric Furnace

By Michael Whedon
Licensed, Certified, Private Fire Investigator

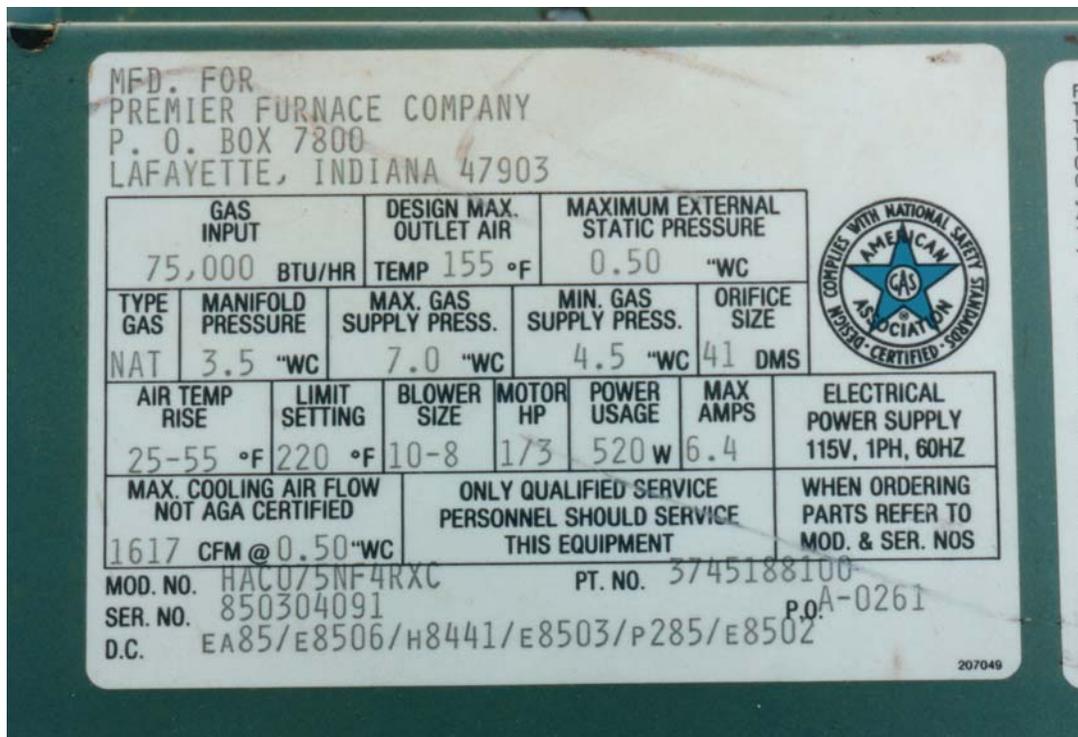
To determine whether a furnace is one of the involved atmospheric H-Series, look on the control side of the furnace for the AGA furnace rating plate. This is a plasticized paper tag which has certain technical information about the furnace as well as the furnace's model number and serial number. (See photo below.) The rating plate may be located on the combustion air intake cover or it may be mounted on the fan door panel. It will always be on the side where the controls are located. The first two or three letters of the model number are used in recognizing the series, modifications, and heat exchanger steel code. The attached list of manufacturers' and model numbers covers furnaces with the Consolidated "Premier" label as well as furnaces sold to other companies and marketed under their labels. If the manufacturer and model number of your furnace appears on the list, you have one of the potentially hazardous models.

To determine when your furnace was manufactured, check the serial number on the rating plate. The first two digits of the serial number indicate the year of manufacture and the third and fourth digits indicate the month. For example, a serial number that begins with the first four numerals of "8706" indicates the furnace was manufactured in June of 1987. The involved H-Series furnaces were manufactured between 1983 and 1991.

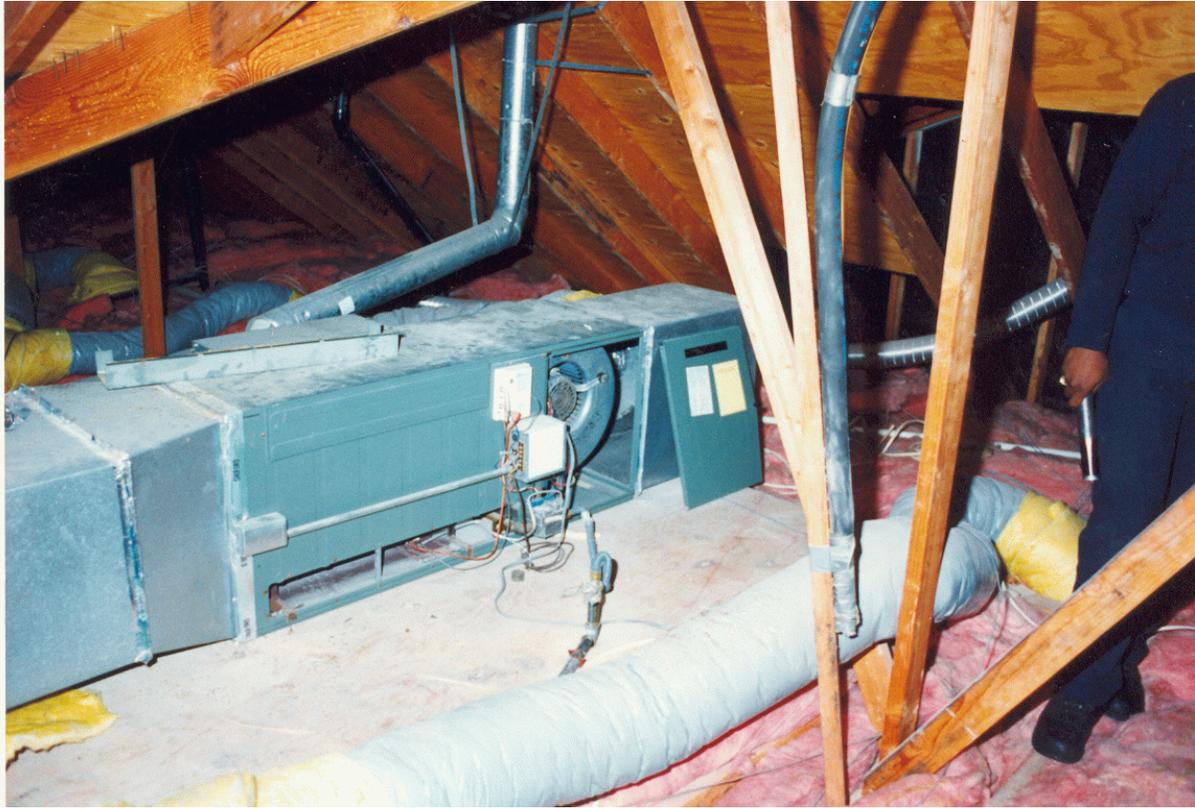
Photo One: Typical installation method for H-Series furnace.

During the same time period, fire investigators began to see an increase in fires occurring in homes equipped with the Consolidated H-Series furnaces. These Consolidated furnaces had been installed in attic spaces on plywood decks or set perpendicular across wooden ceiling joists. The initial theorization was that although the furnaces were rated for installation on combustible surfaces, heat was passing from the burner compartment through the bottom panel of the furnace and igniting the wood decking or joists below. The official fire cause was listed as "pyrolysis," which is simply the decomposition of a fuel due to heat. Not realizing the commonality of the furnaces in these fires, some fire departments and building departments in a joint effort began requiring that all horizontal furnaces installed in attics be placed on non-combustible flooring.

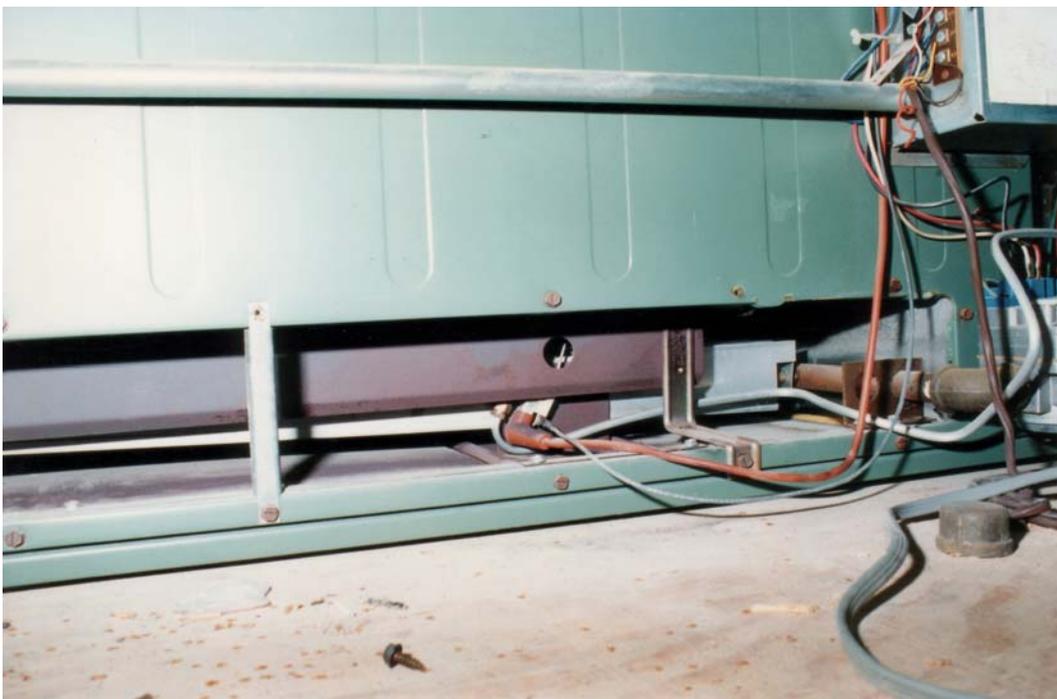
Photo Two: Combustion air intake port at bottom edge of furnace housing.

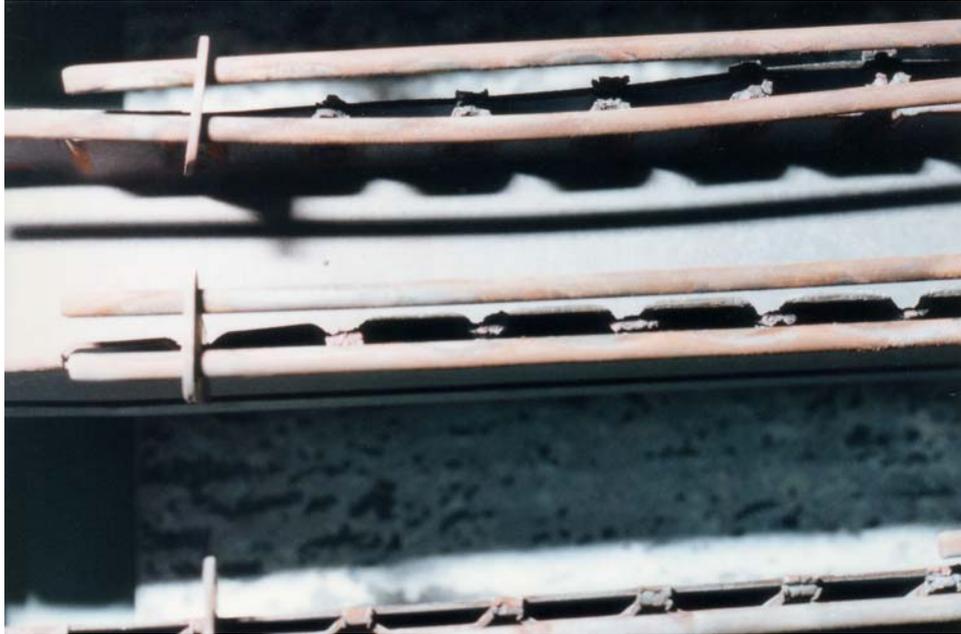
It was determined through observation and testing that small cracks were forming in the metal webs between the gas port openings in the individual burner tubes. After the cracks formed, continued use of the furnace caused the cracks to grow. This resulted in the eventual splitting of the metal between the individual ports which enlarged the port openings to many times their original size. Part of the failure problem was due to internal stresses in the metal caused by the bending in the fabrication process. The problem was further exacerbated by the continuous expansion and contraction of the metal due to heating and cooling caused by operation of the furnace.

Photo Three: Close up view of cracks in the web between burner port openings resulting in the enlargement of the port openings.

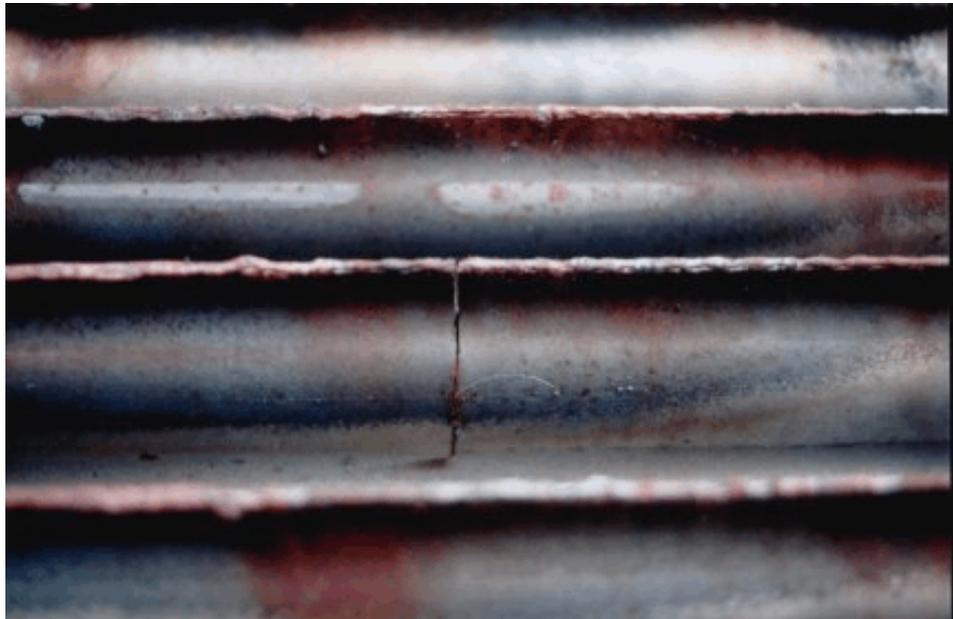
Heat exchangers are made of 18 gauge stamped steel which is machine welded together to form cells or tubes. The purpose of the heat exchanger is to warm the air passing through the furnace before it is discharged into the duct system for distribution into the living space of the house. The metal from which the heat exchanger is formed did not have the ability to withstand the direct impingement of the flames from the damaged burners. Additionally, the weld seams themselves, located along the bottom of the heat exchanger tubes, were also being subjected to this direct flame impingement. These weld seams, which are of relatively poor quality, would fail quickly when exposed to the direct flame contact. Lateral cracks would begin to form in the weld seams

leading to horizontal cracks in the walls of the heat exchanger cells. Under continued use, these cracks widen and grow in length. The metal crystallizes and begins to literally fall apart. This results in continued growth of the holes in the heat exchanger cells.

Photo Four: Close up view of vertical crack in heat exchanger cell.

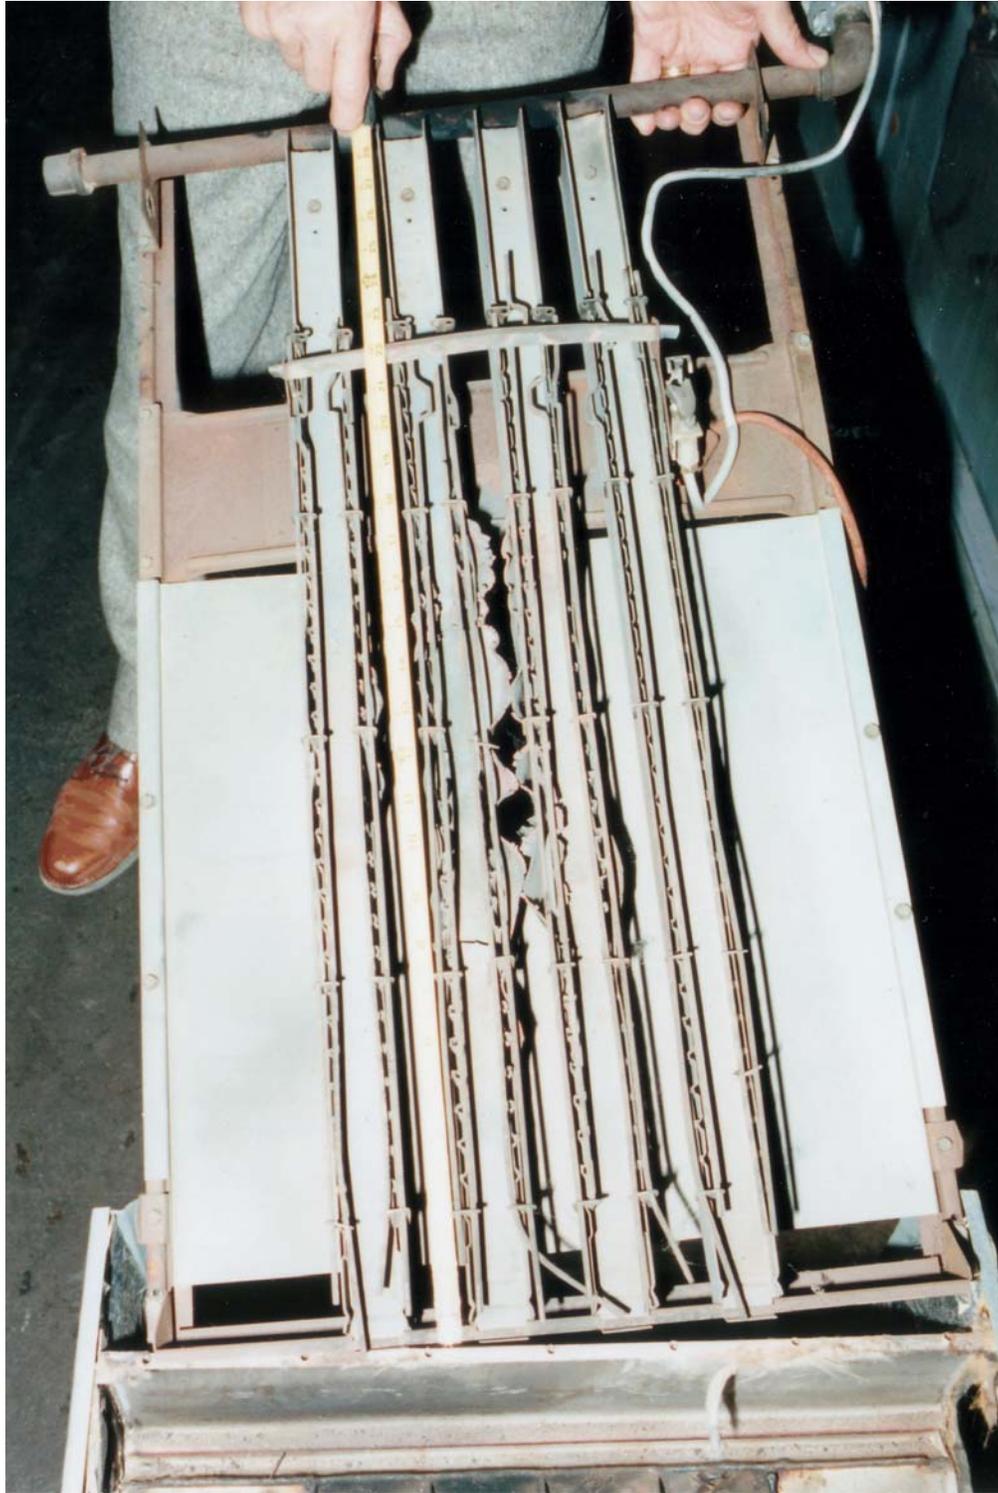
Photo Five: Damaged NOX rod equipped burner assembly.

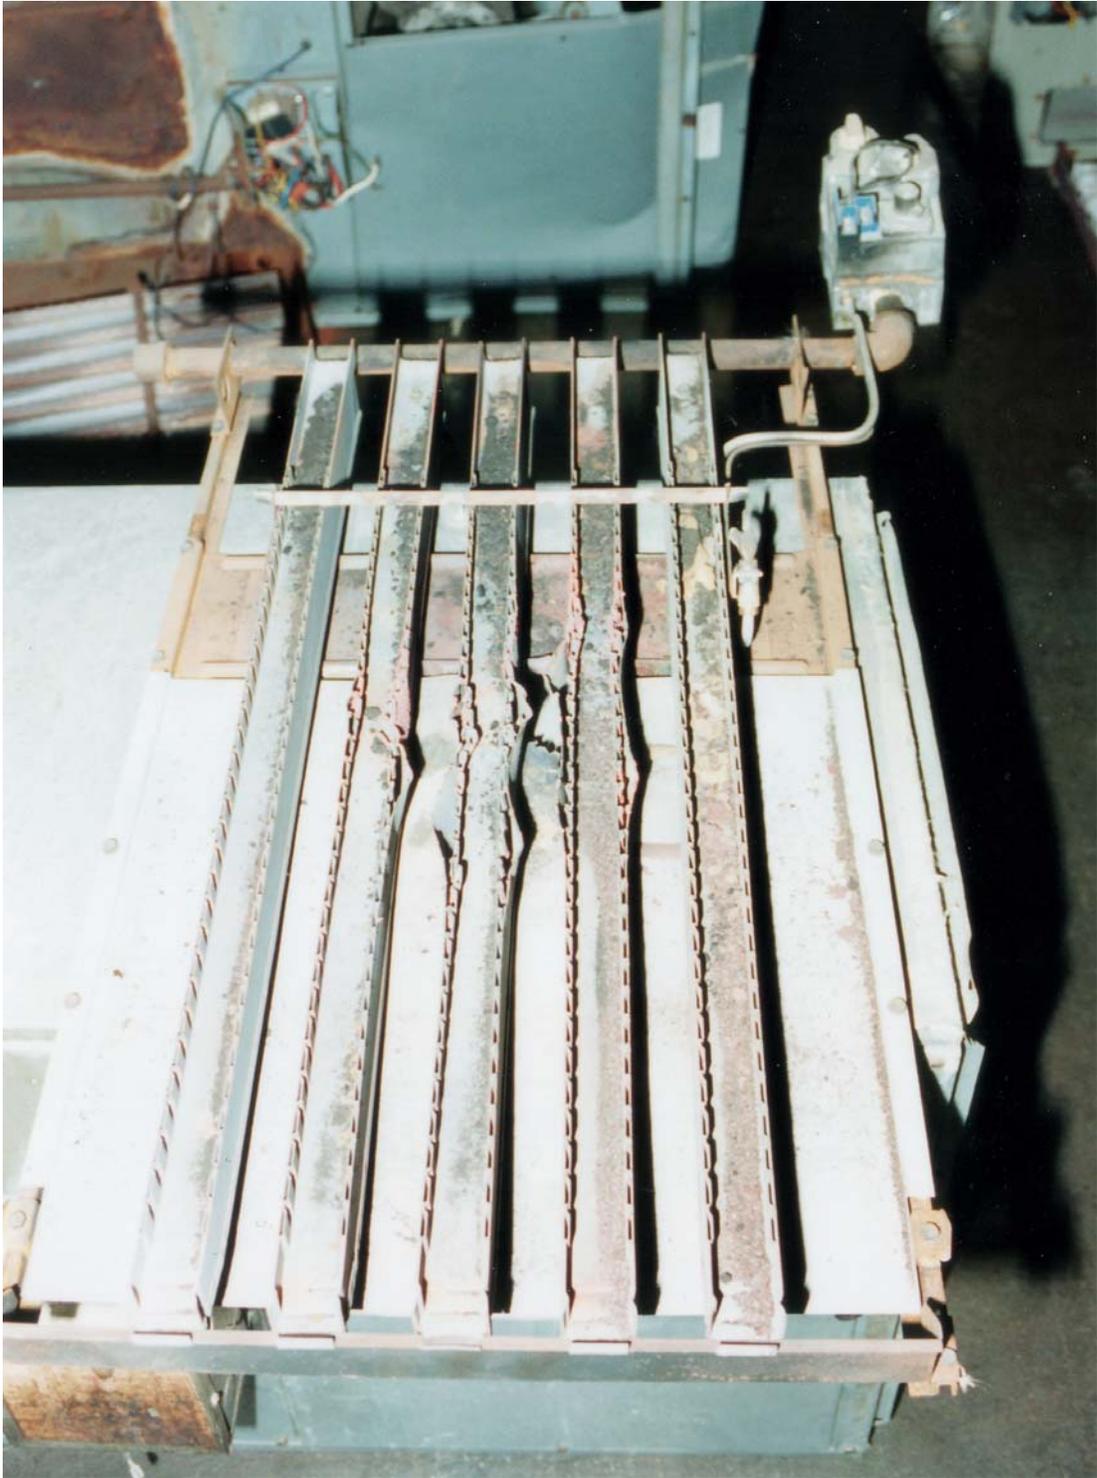
Photo Six: Damaged burner assembly not equipped with NOX rods.

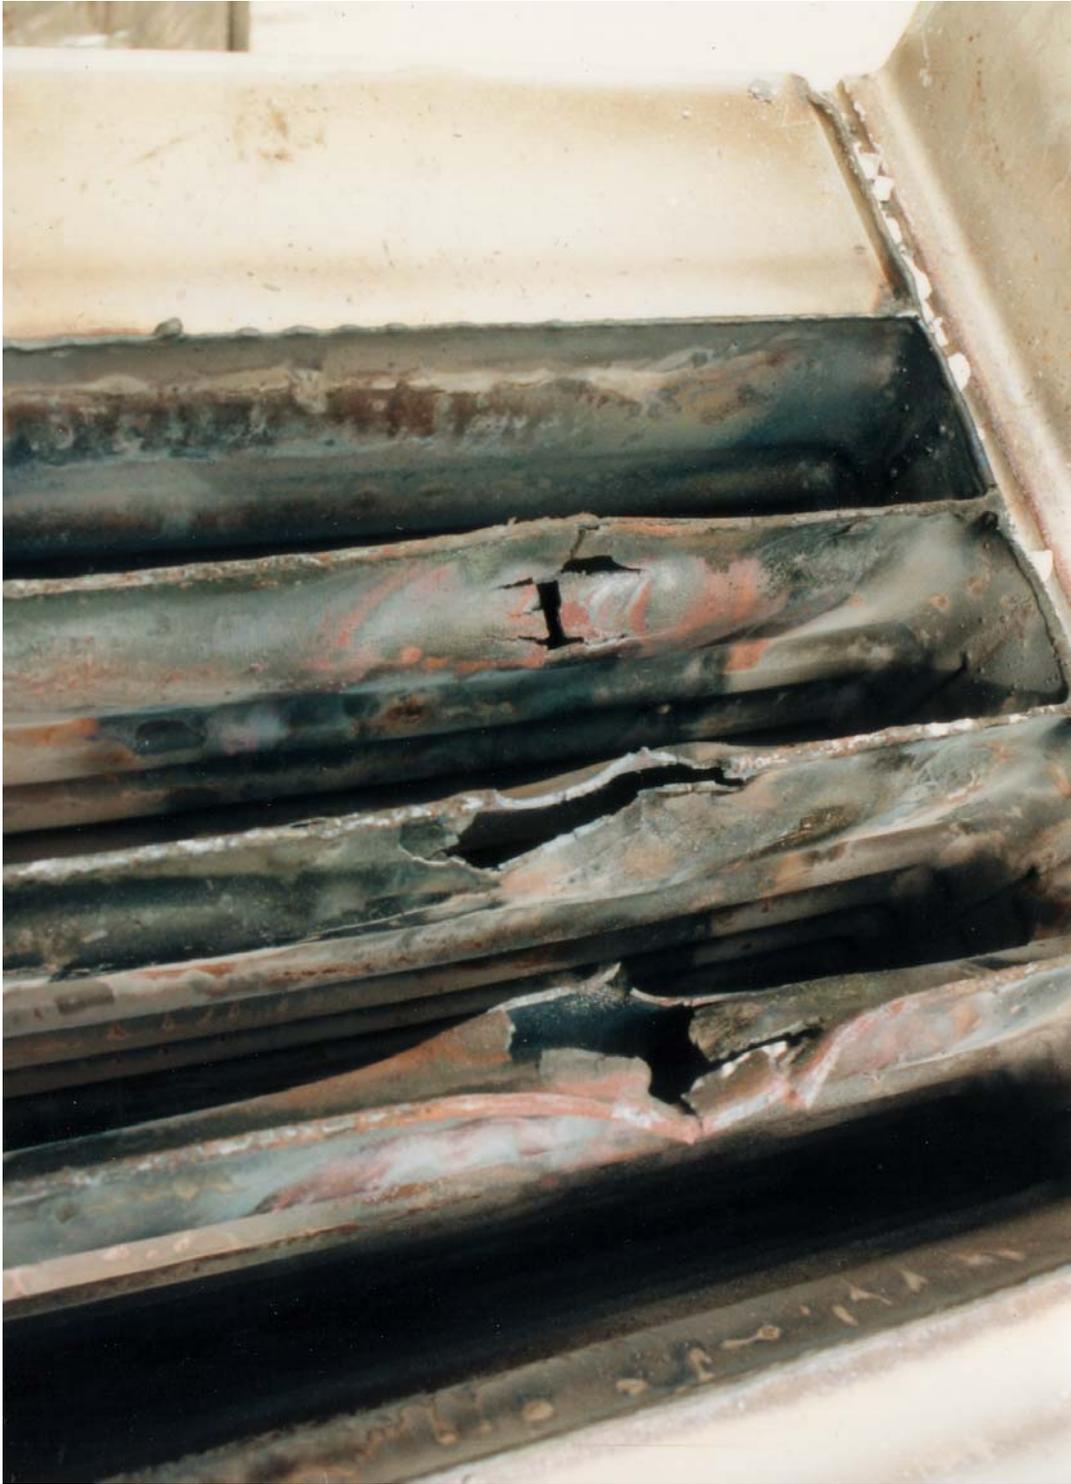
Photo Seven: Failed heat exchanger.

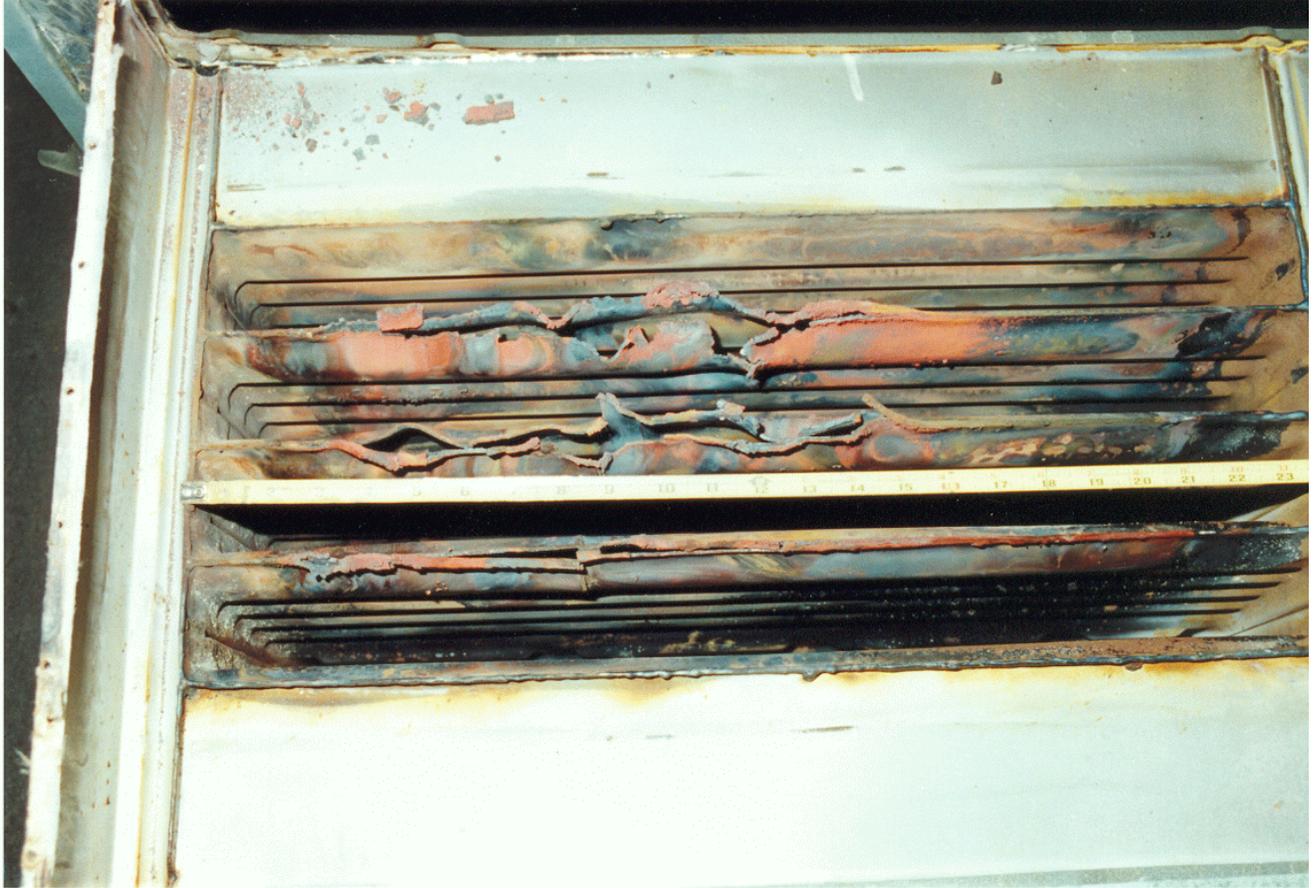
Photo Eight: Major failure of heat exchanger.
