# Real Estate Inspection Report

Prepared Exclusively for: Rick & Darlene Carter  
on  
1/1/10

2567 Allen Town Way Sacramento, CA

**Report #SAMPLE09**

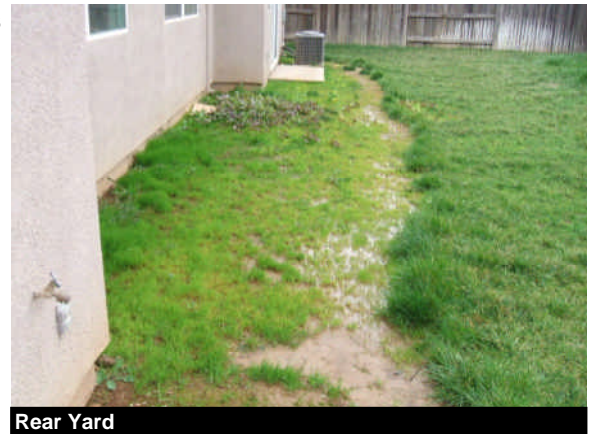
[MRR] Drainage near the building is improper. There are several areas around the building which do not maintain a positive slope away from the building. Moist soil conditions near the foundation can cause settlement of the structure. There should be a 2% slope for at least 6' away from the foundation.

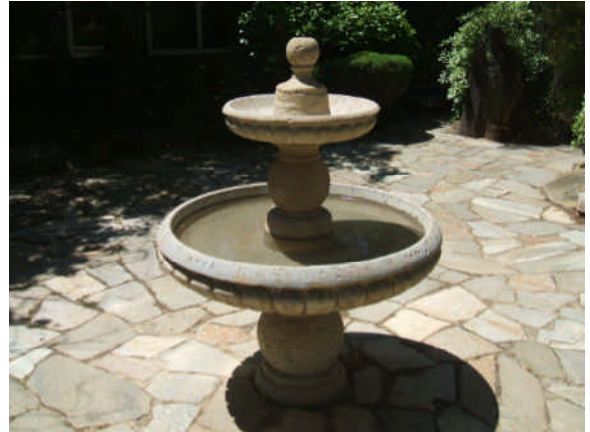
[HSC] A fountain was observed at the rear yard. Pieces are not securely fastened in place. Unsecured pieces could fall onto a child or other person. It is recommended that a qualified person mount the fountain pieces securely.

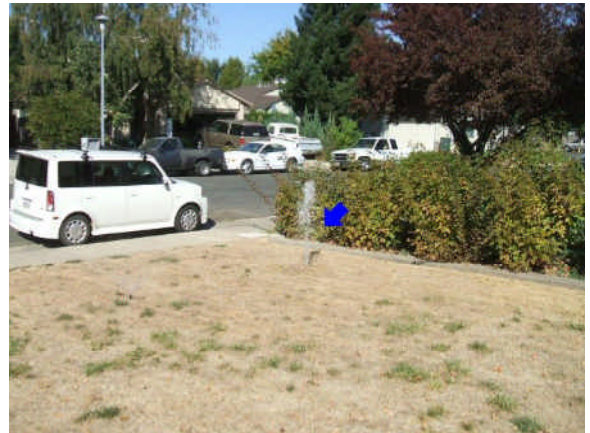
[MRR] Several sprinkler heads are missing in the front yard.

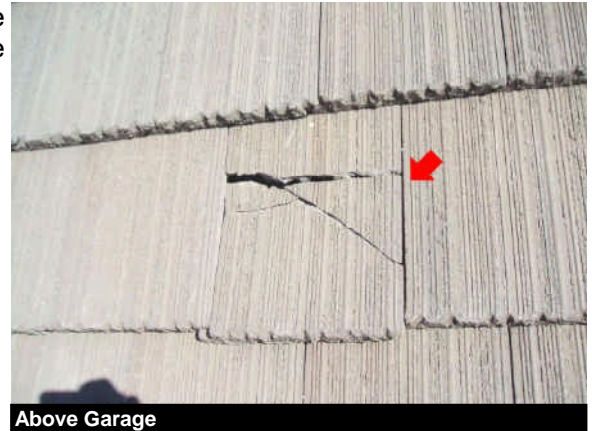
[MRR] The inspection of the roof covering revealed one broken roof tile above the garage. Recommend a competent roofing contractor replace the tile.

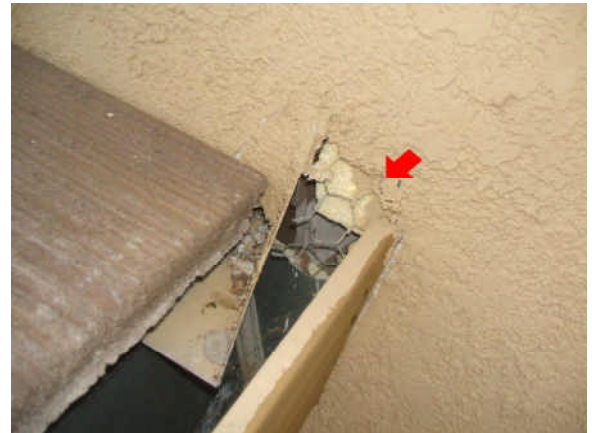
[MRR] There is a void in the stucco where the gutter meets the wall above the left side of the entry. Recommend a competent contractor correct this condition to prevent the possibility of moisture intrusion.

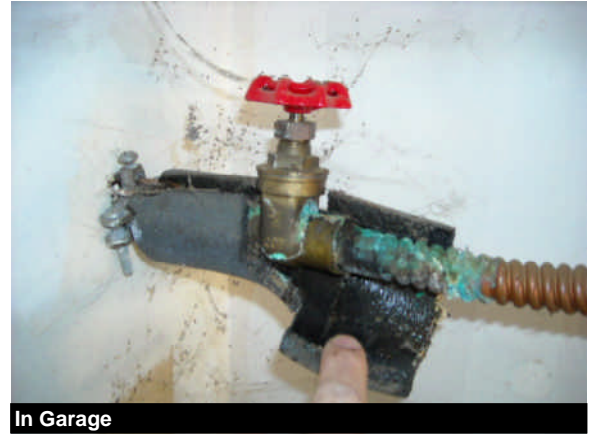
[MRR] Water observed to be leaking at the cold water shut off valve at the water heater. Recommend a competent plumber repair this condition before damage to the surrounding walls results.

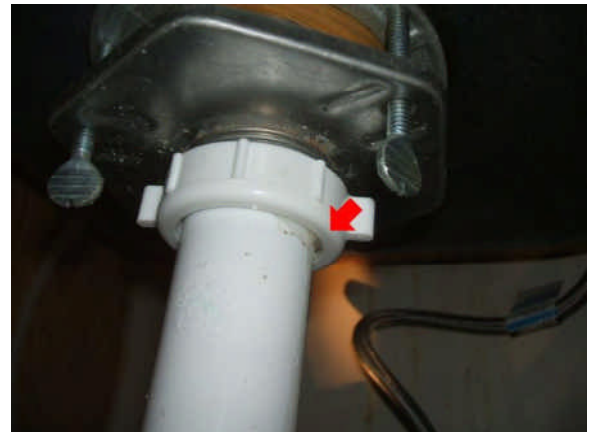
[MRR] Water was observed to be leaking from the kitchen sink drain tailpiece. Recommend corrections before damage to the cabinet or walls results.

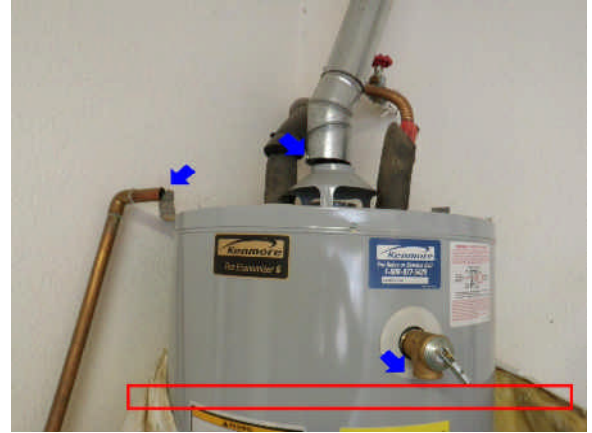
**[HSC]** The temperature pressure relief valve discharge line is not connected. This valve and discharge line is a safety device, which will expel steam and hot water in case the water heater malfunctions. The vent pipe atop the water heater is not connected. This may lead to products of combustion, including carbon monoxide to spill into the garage. The water heater has no seismic strapping, as required by the State Department of General Services, Division of the State Architect. Recommend a competent plumber perform corrections.

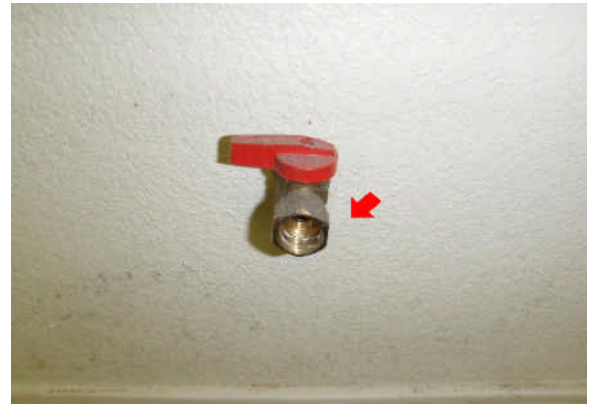
Gas Valve in Laundry Room

**[MRR]** If a gas dryer is not used, recommend a competent plumber install a proper fitting plug into the gas valve to prevent gas from escaping if the valve were accidentally opened.

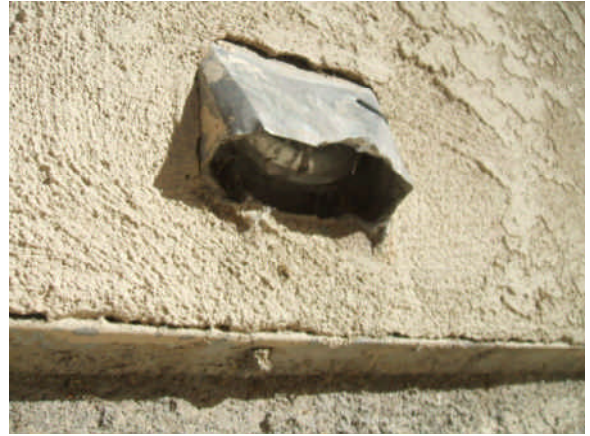
[MRR] The dryer vent exhaust hood at the right side of the home is damaged. This doesn't allow the flapper door to open fully. This may cause the dryer to overheat and take longer for clothes to dry.

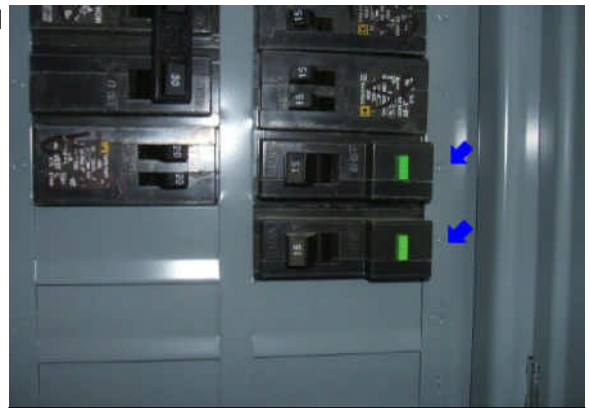
AFCI Breakers

The electrical service was provided by underground feeders connected to the main service panel located at the left side of the building. The electrical system is a 120/240V service and the main breaker is rated at 200 amps. The house ground connection was observed to be connected to a conductor or rebar embedded in the foundation. This home has AFCI's installed at the main panel. The AFCI's in the main panel were tested and found to function properly, tripping the breaker when the button was pushed and cutting power to the bedroom lights and receptacles. We recommend you test yourself on a regular basis, per manufacturers instructions. The majority of the circuits in this home are wired with non-metallic cable and stranded aluminum conductors. Conditions are noted below.

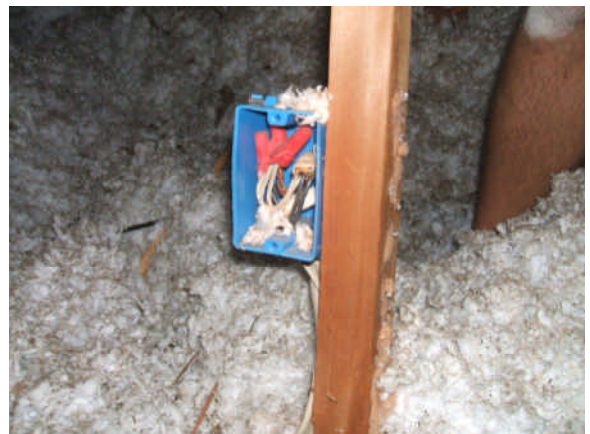
[MRR] Junction box cover missing in attic. Located near the attic access.

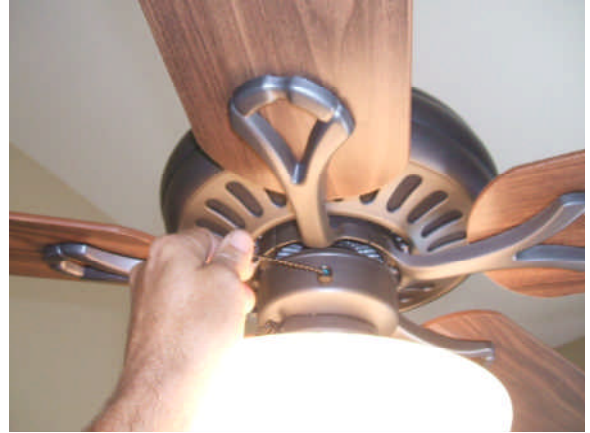
[MRR] Fan speed control switch is damaged at the ceiling fan in master bedroom. Pull chain/switch does not work. Fan only operates on slow speed. Recommend corrections by a competent person.

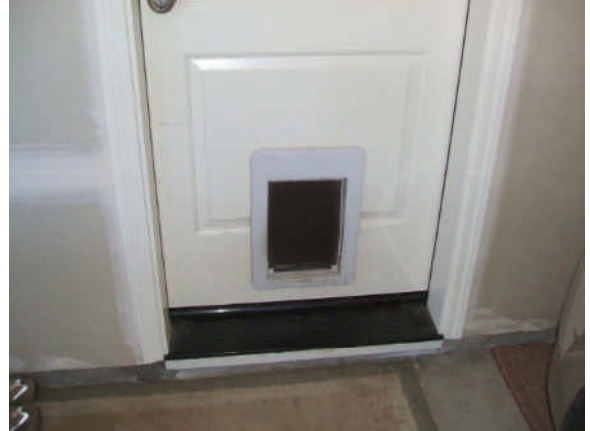
**[HSC]** The door between the kitchen and garage has a pet door installed. This breaches the fire rating of the door. Fire rated doors should be solid, with no openings.

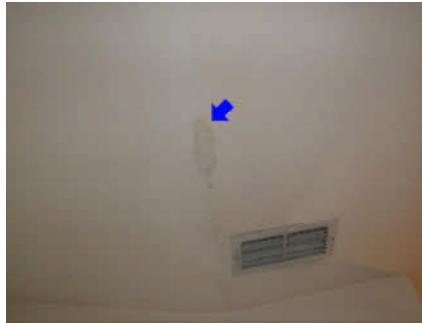
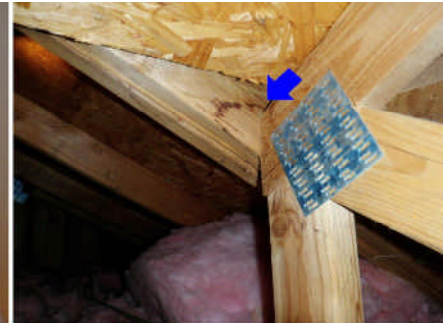
**[MRR]** Moisture staining observed on the ceiling in the living room. Moisture stained lumber observed in the attic above this area. Recommend a competent roofer review this condition and provide cost estimates for repairs before the close of the transaction. Moisture infiltration will damage the structure.

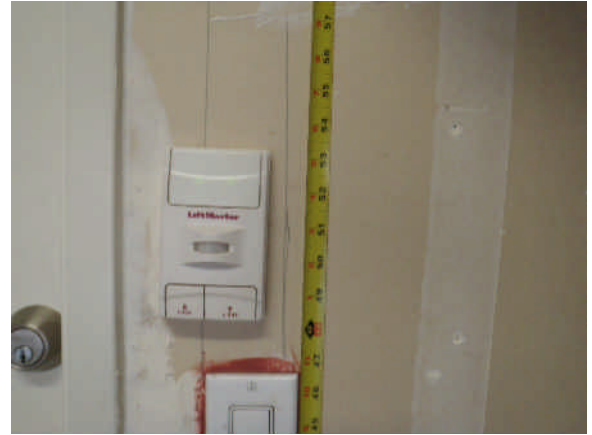
[HSC] The garage door opener button mounted on the wall in the garage was found to be lower than 60". This can allow a child to operate the garage door. Recommend a competent person perform corrections.

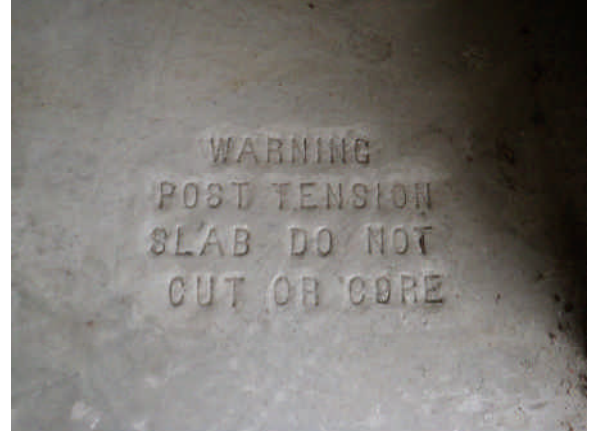
A concrete slab foundation was noted. Because of floor coverings, the condition of the slab was not observable and excluded from this inspection. This concrete slab is known as a "post tensioned slab," meaning it has cables running through it which are under tension. **DO NOT** alter or cut this slab in any way. Serious injury can result. If any alterations to the foundation or slab of this home are to be done, a qualified and licensed concrete contractor should be consulted.

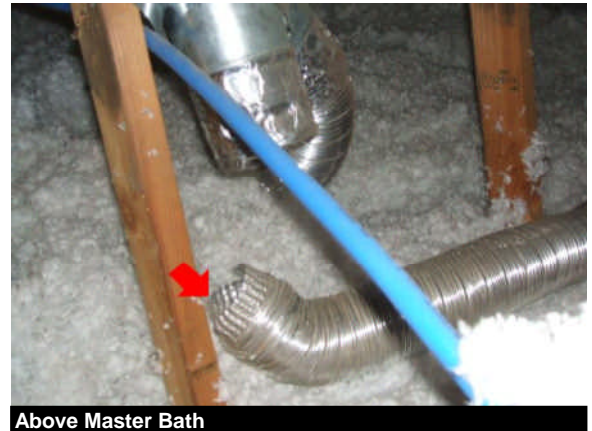
Above Master Bath

[MRR] The ventilation duct above the master bathroom is disconnected. Recommend a competent person install 2 screws to hold it in place.

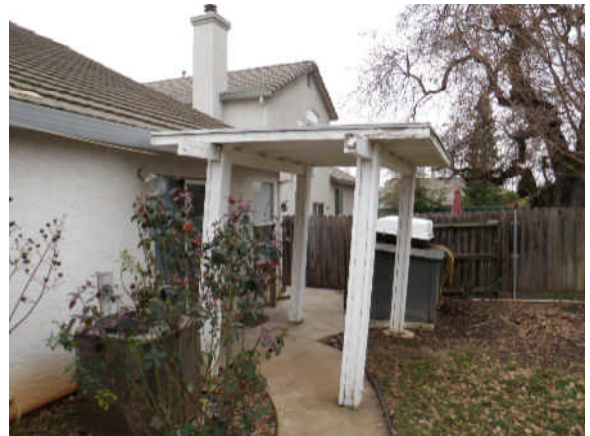
[HSC] The patio cover at the rear of the home is leaning. There are no lateral supports and it may fall over. Recommend a competent contractor repair it or have it removed.
